TEST REPORT

LED Strip Connector

Model:Hippo-M SDP

Test Standard: : IEC 60068-2-1:2007 & IEC 60068-2-2:2007

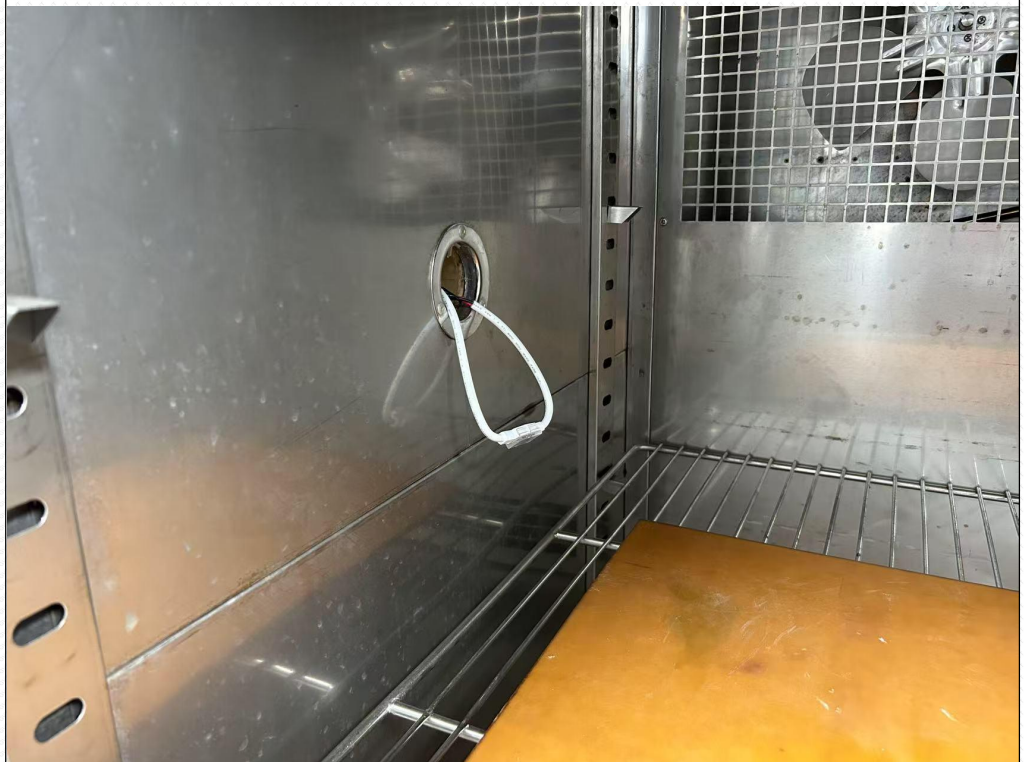
Photo 3

View: Place before
the test

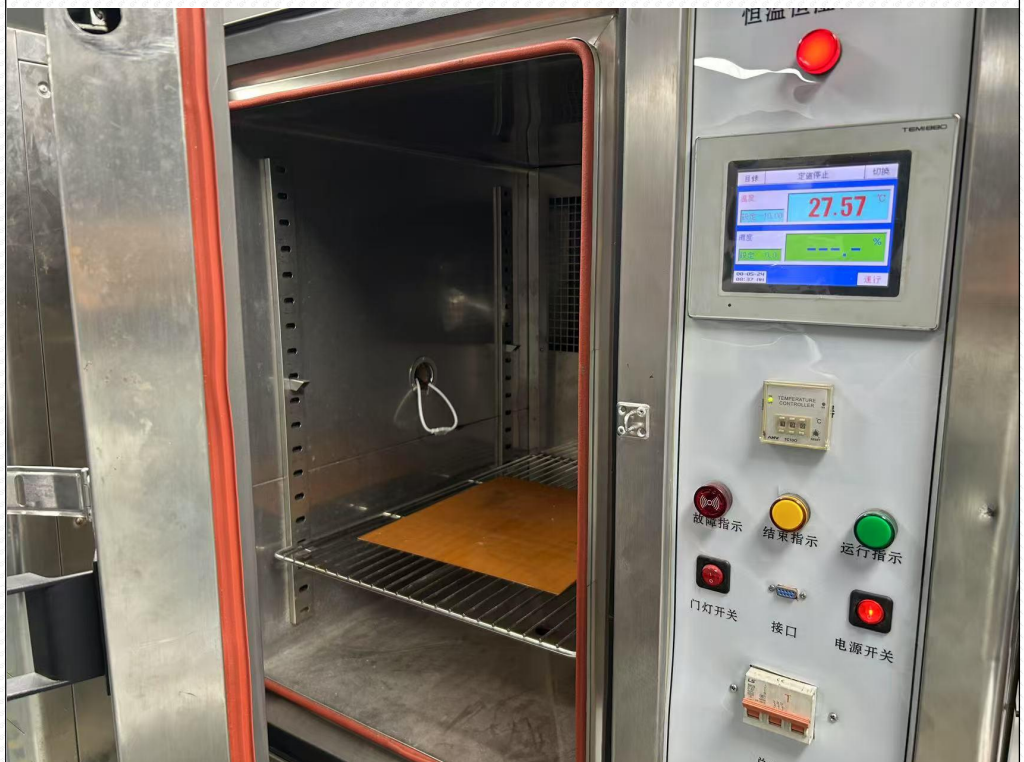
**Photo 4**

View: Place before
the test

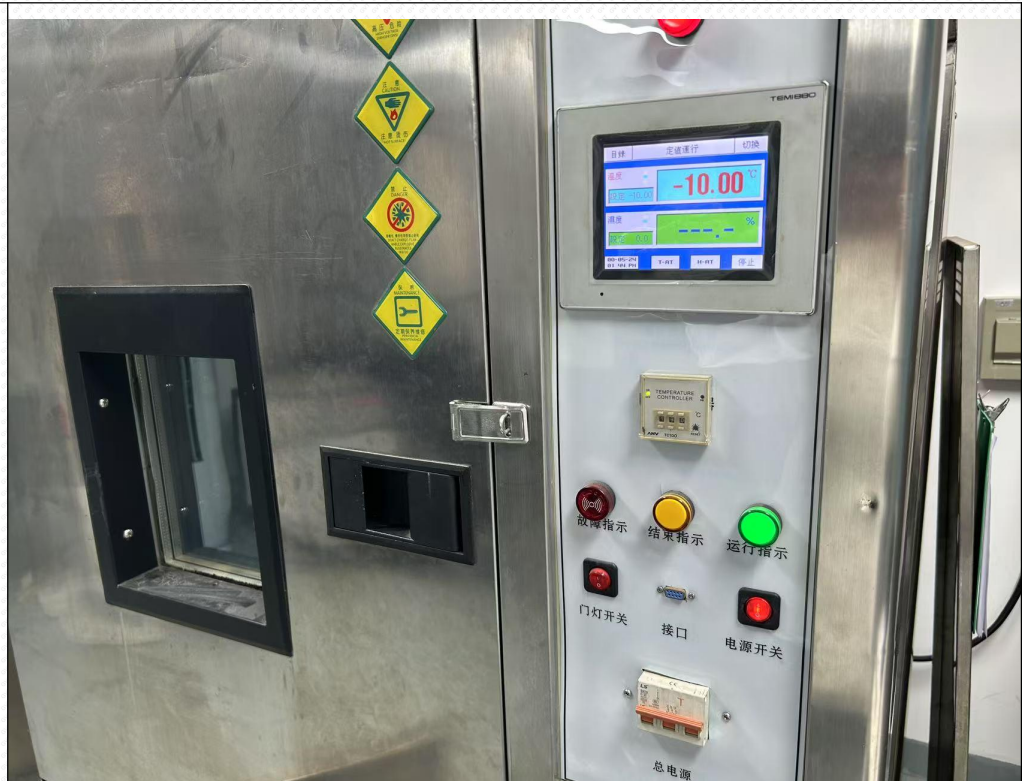
Photo 5

View:
Testing(-10℃)

| Low temperature test | <p>Test conditions:</p> <p>(1) Sample status: Normal, Power on and start up</p> <p>(2) Test requirement: -10℃</p> <p>(3) Test time: 48h</p> <p>Test procedure:</p> <p>(1) The sample were pretreated and left at room temperature for 25℃ for 2h, Observe whether the sample state and function are normal;</p> <p>(2) Start testing: Place the sample in a constant temperature and humidity testing chamber, and set the testing chamber conditions to -10℃ , Run continuously for 48 h under the condition</p> <p>(3) End of test: remove the tested sample from the test box and restore them in room temperature for 2 hours.</p> <p>Requirements:</p> <p>Conduct appearance and assembly inspections, requiring no abnormalities in appearance or assembly;</p> <p>The sample whether work normally after returning to room temperature.</p> | Meet the requirements | P |

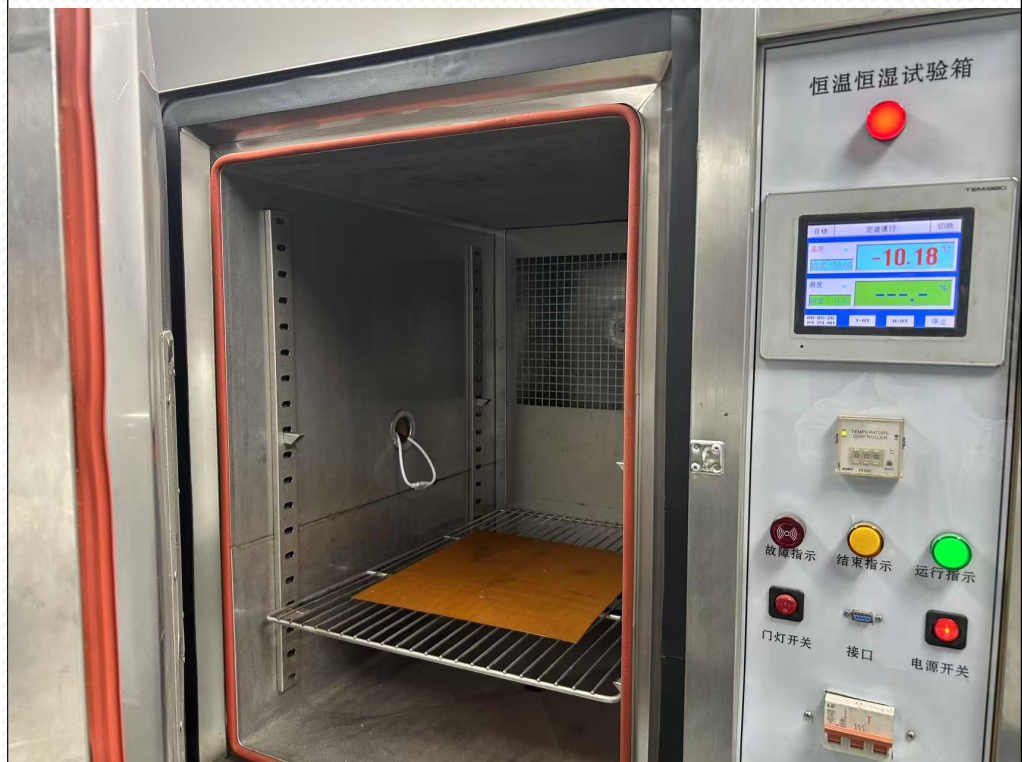
**Photo 6**

View:
Test end

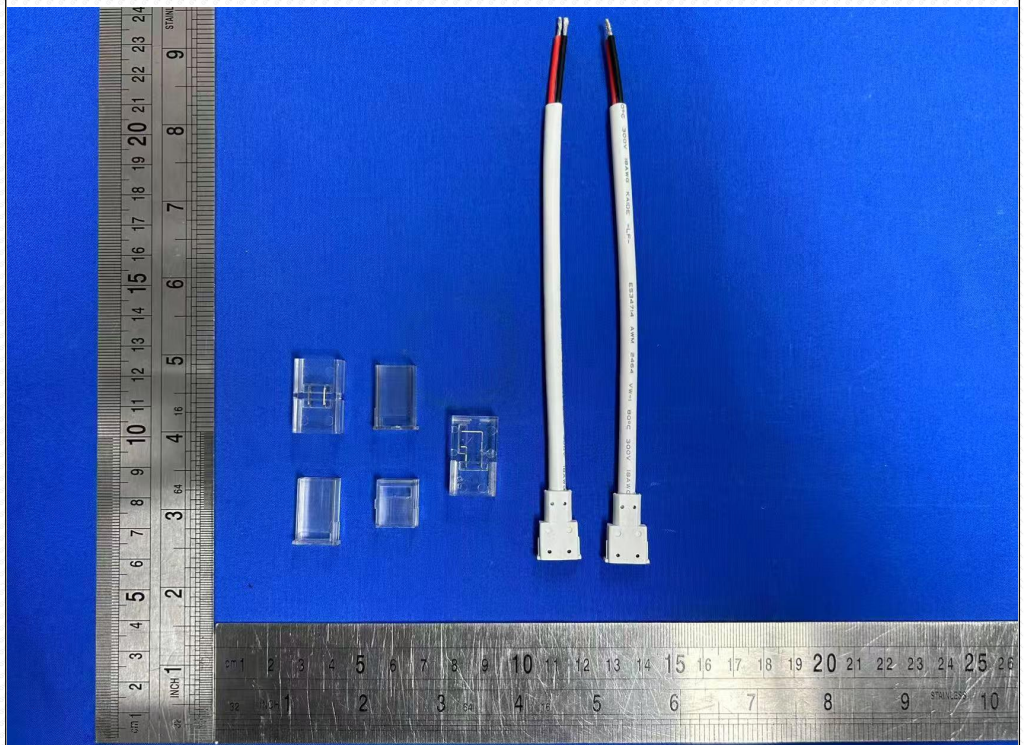
Photo 2

View: Before the test

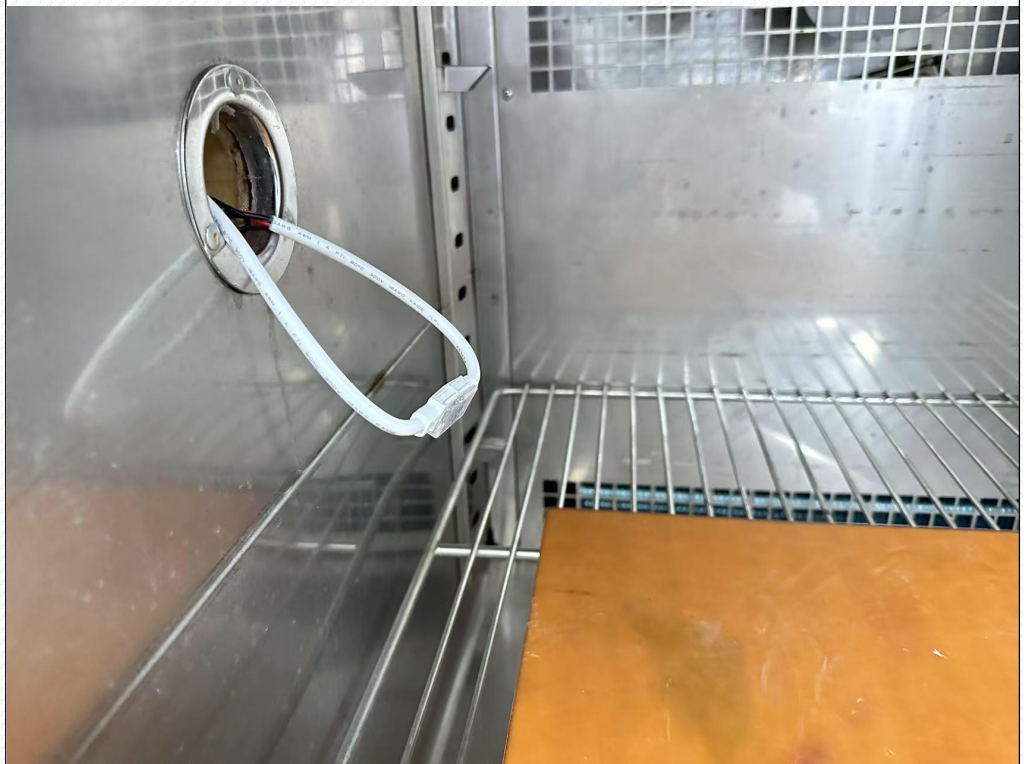
Photo 3

View: Place
before the test

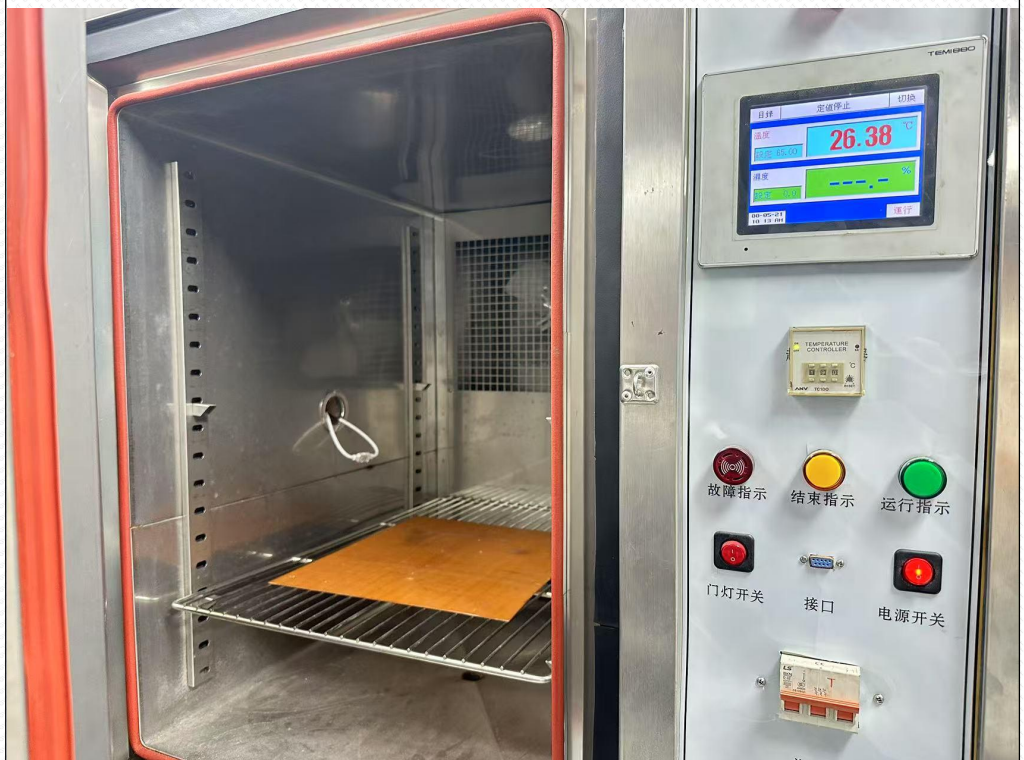
**Photo 4**

View: Place
before the test

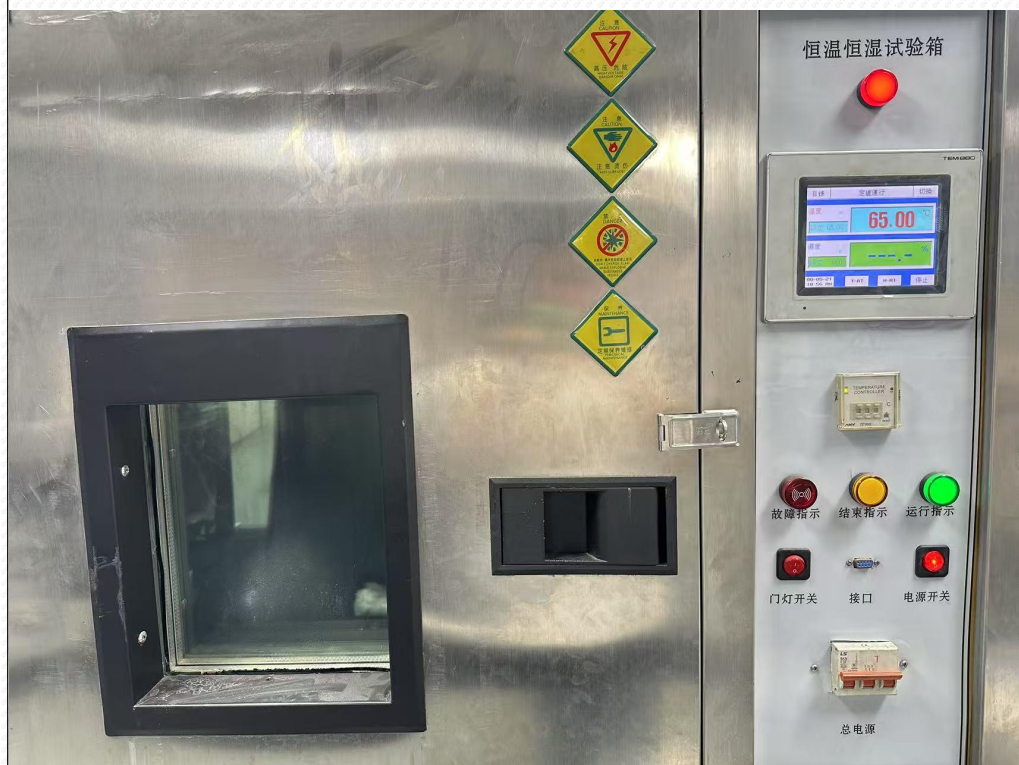
Photo 5

View:
Testing (65°C)

| High temperature test | <p>Test conditions:</p> <p>(1) Sample status: Normal, Power on and start up</p> <p>(2) Test requirement: 65°C</p> <p>(3) Test time: 48h</p> <p>Test procedure:</p> <p>(1) The sample were pretreated and left at room temperature for 25°C for 2h, Observe whether the sample state and function are normal;</p> <p>(2) Start testing: Place the sample in a constant temperature and humidity testing chamber, and set the testing chamber conditions to 65°C , Run continuously for 48 h under the condition</p> <p>(3) End of test: remove the tested sample from the test box and restore them in room temperature for 2 hours.</p> <p>Requirements:</p> <p>Conduct appearance and assembly inspections, requiring no abnormalities in appearance or assembly;</p> <p>The sample whether work normally after returning to room temperature.</p> | Meet the requirements | P |

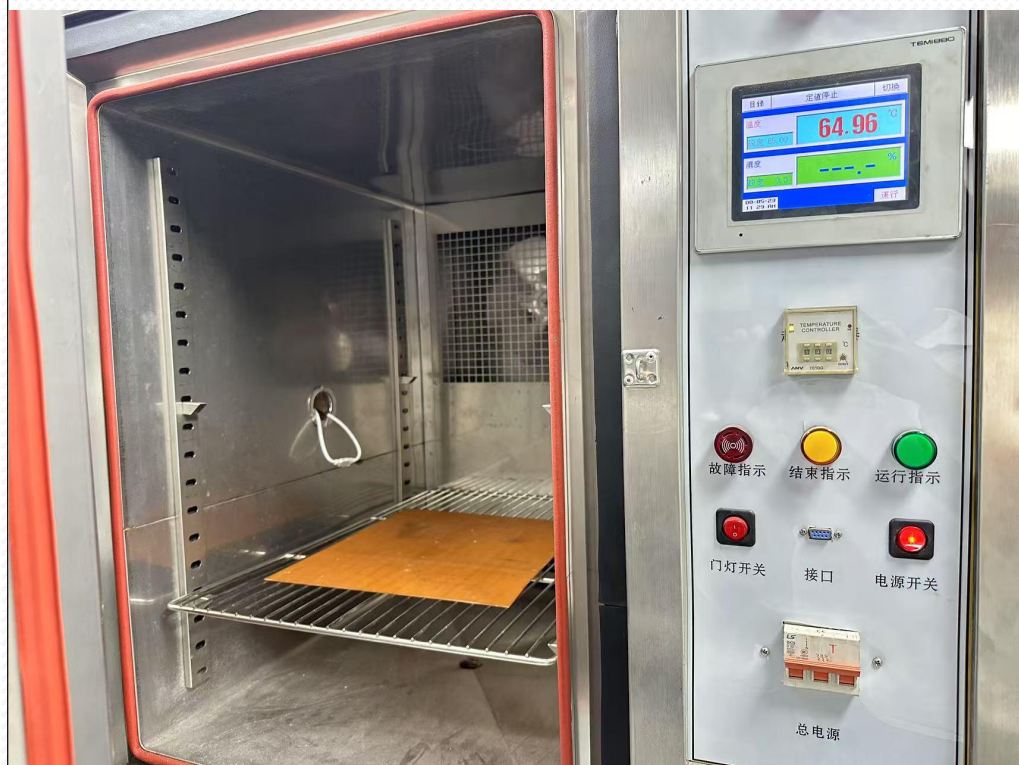
**Photo 6**

View: Test end
