Sample Name: Beetle Clip Invisible  
Sample Model: Beetle Clip Invisible  
Amount of sample: 1pcs  
Sample Received Date: 2020/09/30  
Testing Period: 2020/09/30~2020/10/15

**Test Requested:** Salt spray test

**Test Method:** According to IEC 60068-2-11:1981 and the clients' requirement

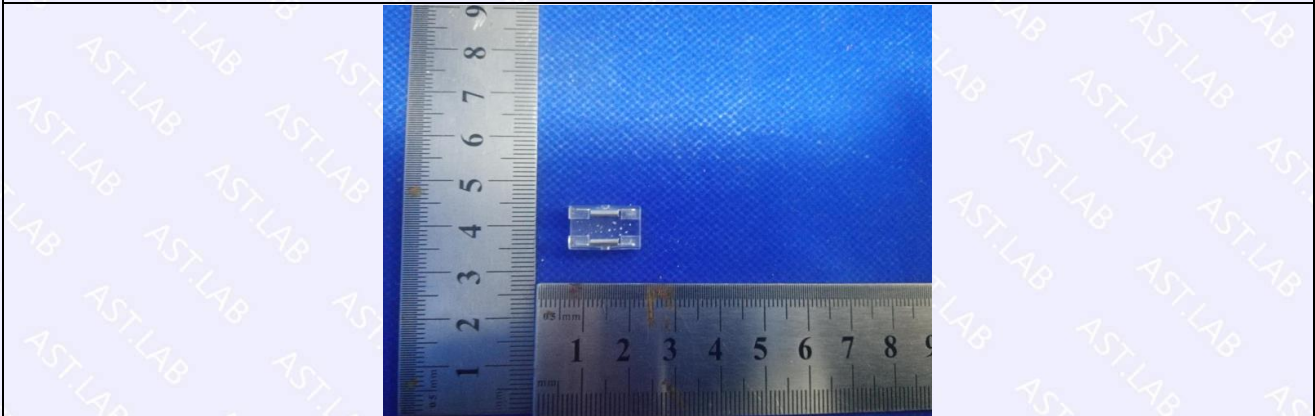
After test

Sample No.	Sample name	Test Results (visual observation)
001	Beetle Clip Invisible	No Corrosion was found on the surface of the samples
